## WELDING INSPECTION REPORT

Resident Engineer: Siegenthaler, Peter **Report No:** WIR-021493 Address: 333 Burma Road **Date Inspected:** 28-Feb-2011

**Project Name:** SAS Superstructure **OSM Arrival Time:** 700 **OSM Departure Time:** 1730 **Prime Contractor:** American Bridge/Fluor Enterprises, a JV

34-0006 **Bridge No: Component:** S.A.S. components

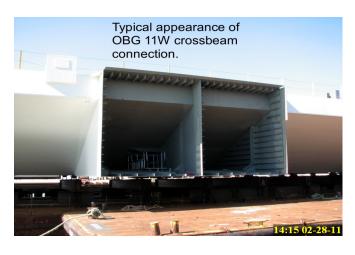
The QAI made random observations / measurements of the welding parameters as the welding was being performed. The QAI noted that the welding voltage, current, preheat and interpass temperatures appeared to be within the WPS requirements. The QAI also noted that as the root welding progressed, cracked tack welds were being removed by grinding. The QAI was informed by the QC Inspector that magnetic particle testing (MT) is being conducted on the tack weld removal areas. The QAI observed that several (8) tack welds visible along the cover plates and the PJP weld appear to be cracked. The QAI was informed that these will be removed after the CJP welds get filled with the 2nd layer. See the attached photos.
